# Anodizing and Fatigue Life

Stu Fields

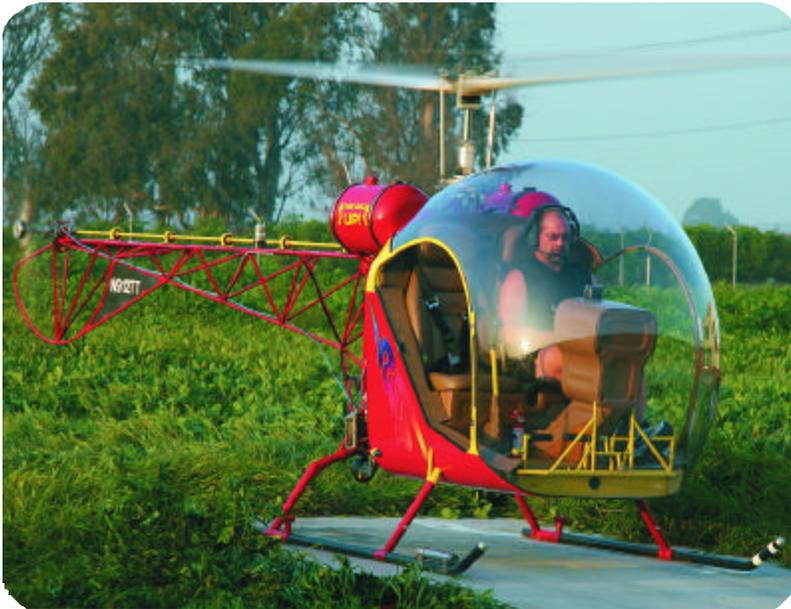
**Gilbert Goodlett's award winning ship -- before**

Here is a photo of an Oshkosh Grand Champion Rotorcraft winner labeled before:

This gorgeous Safari helicopter was lost due to fatigue failure in a control tube, and it had only flown a few hundred hours.

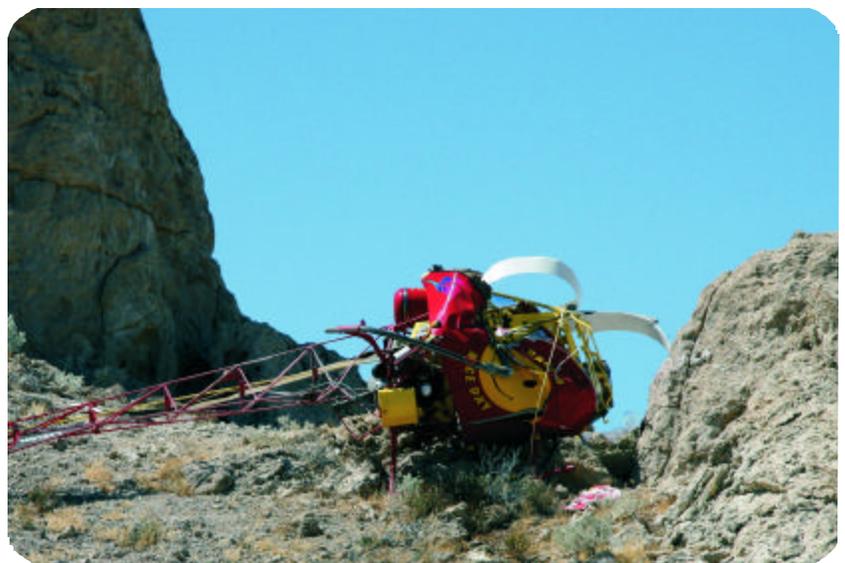
**Gilbert Goodlett's award winning ship -- after.**

Here is a photo of the same helicopter labeled after:

**The good news is that Gilbert walked away from the crash with only a sprained ankle -- walked, in fact, several miles before reaching cell phone service**

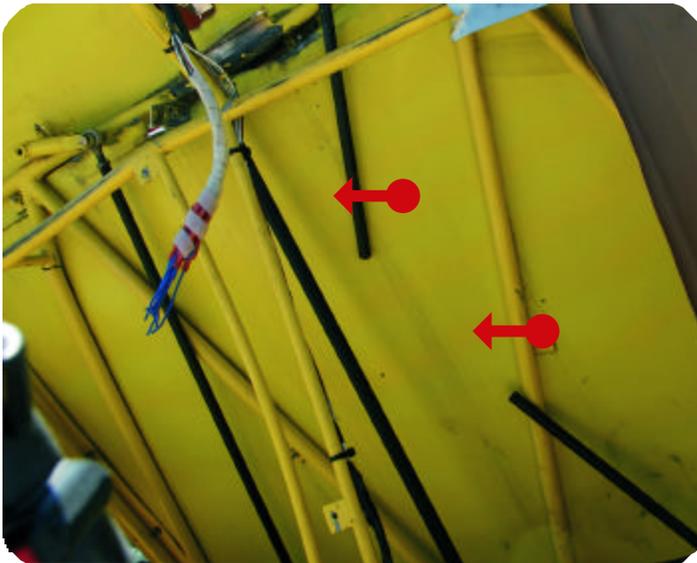
**Photo A: Still in-place, but broken, control rod at the scene of Gilbert Goodlett's crash. This rod failed in fatigue after only a few hundred hours. A possible answer to, how was this possible, is that this rod was anodized to increase the ship's curb appeal**

One answer to this question was: The rods were anodized black to add to curb appeal.

I now have a feeling for why some of the folks at the plating shops just said: "Do not plate or coat flight critical components, unless you really know what you are doing and can offset the problems created by these processes."

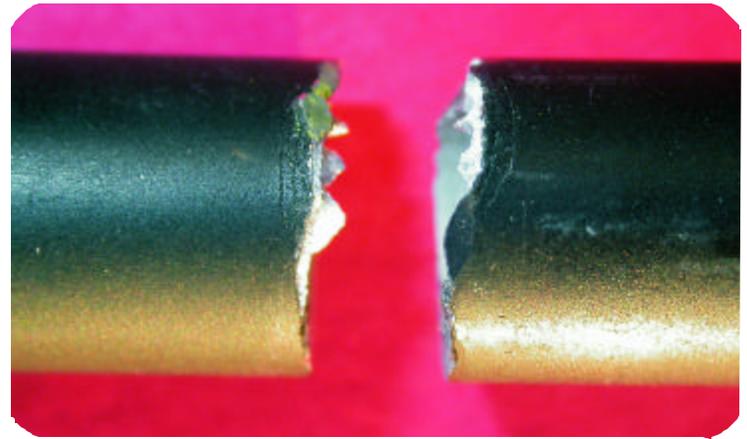
The anodizing people said that anodizing would do this. But how did the process cause stress in the Safari control tube to exceed the Endurance Limit? For, again, the evidence showed that the control tube failed due to fatigue. There was no evidence of a pre-existing crack or notable surface discontinuity existing

**Photo B: A real close up of the two broken ends of Gilbert's control rod**

prior to the anodization that might lead to a stress riser.
